## ADDENDUM #2

**To:** Demolition and Abatement Contractors  
**For:** Iowa Juvenile Home Environmental Remediation and Demolition Services  
**Project:** 13227024  
**From:** Terracon Consultants, Inc., on behalf of the City of Toledo, Iowa  
**Subject:** Addendum #2  
**Date:** September 20, 2022

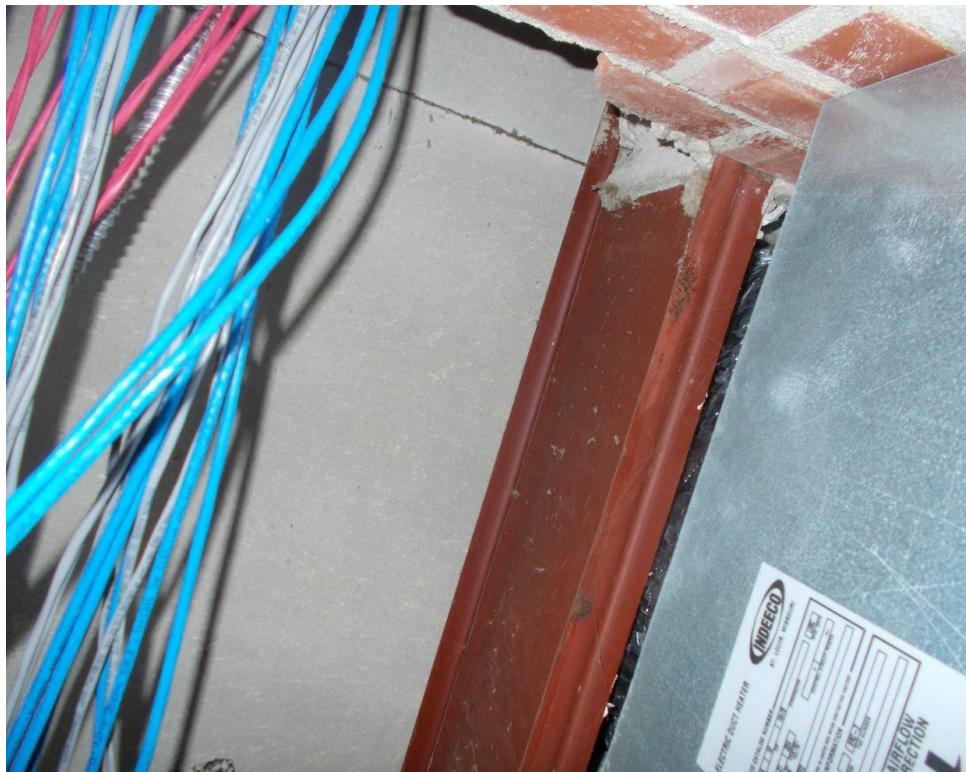
**Photo 1.** Skow Transite.

**6. Note:** Skow Cottage contains asbestos containing cement board (Transite) and an asbestos containing adhesive atop of structural steel and below roofing materials. Based on additional investigation completed on September 19, 2022 on Skow Cottage, the contractor should be aware that both the roofing materials and the plaster ceilings below (interior side) may need to be removed to access and abate the asbestos containing materials, as shown in Photo 1, below. Duct work, cabling, piping, fire systems, demising walls, drop ceilings, ACT, and other materials may need to be removed to complete ceiling demolitions and Transite abatement. The roof matrix of Skow Cottage appears to consist of the following (from top to bottom): rubber membrane>gypsum board>4-inches of foam insulation> tar/built-up roofing >1-inch fiber board>ACM adhesive (black)>ACM Transite, see photo 2 below. The contractor will also likely need to remove the fiberboard as ACM waste.
